Cantilevered Floor Evaluation

RE: Floor joist bleeder ducts

11/17/02

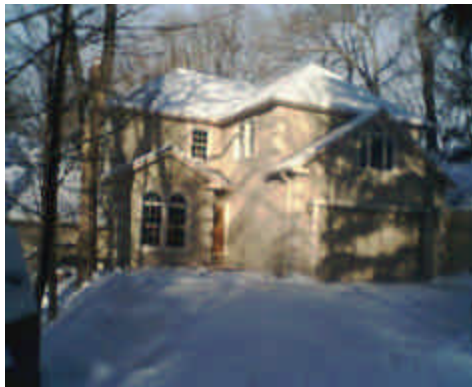
My home is a 2 story with a finished walk out lower level and a finished attic. The EIFS stucco system has looks, added insulation value and is an exterior air barrier. This picture is from a previous winter.

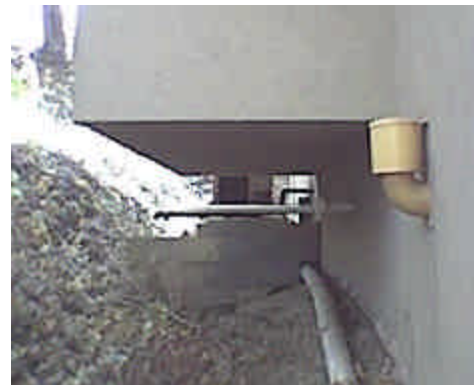
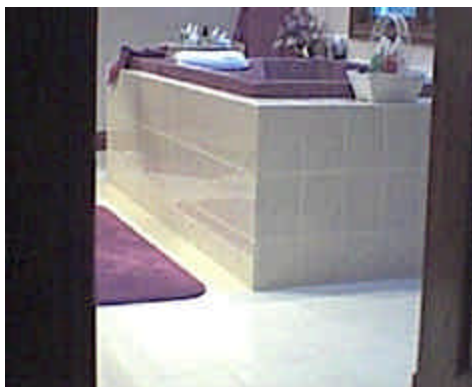
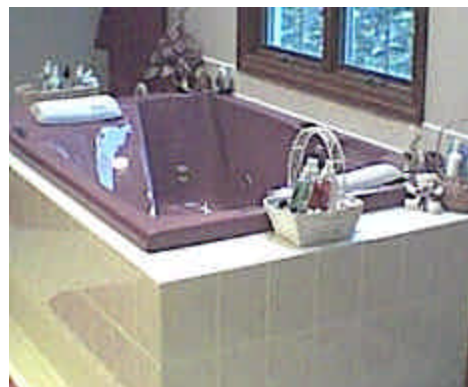
The master bath has a 4' cantilever to accommodate a Jacuzzi tub. The bottom side is wrapped with the EIFS system. This is the north, sun shaded side of the house.

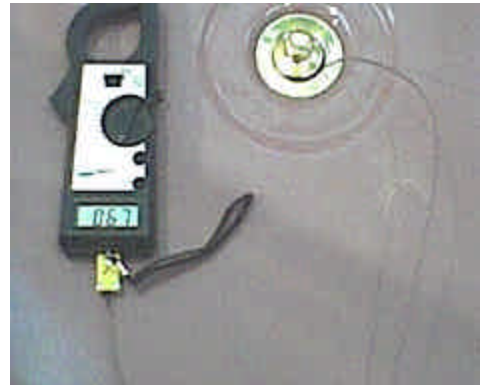
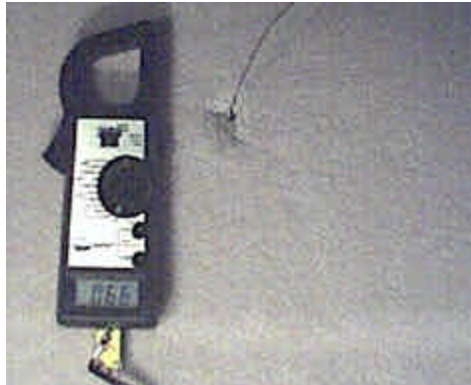
Floor #1: The master bath is cooler than other rooms in the house. Temperatures were recorded as follows:

Outside walls 63°F; cathedral peak 63°; cantilever floor 63-65°; other floor 65°; tub surface 62°; tub drain (approx. 2' into pipe) 67°; the kitchen ceiling below was 68°.

The area under the tub is within the thermal envelope.

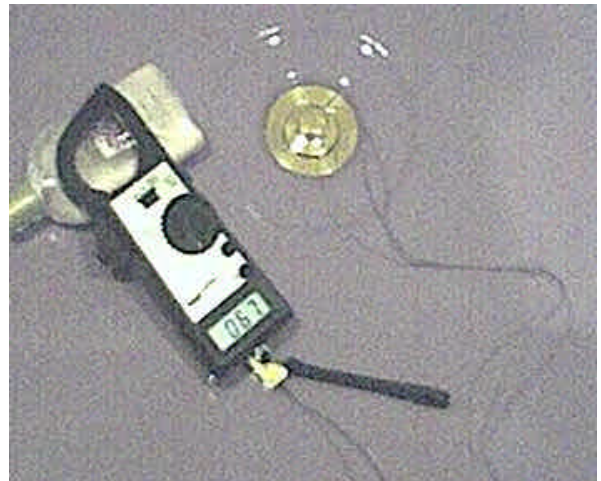
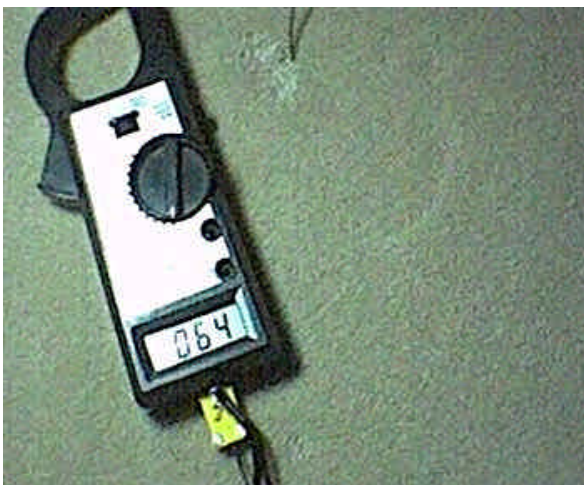
Floor #1:

The Master Bath under tub temperature as measured 2' into the Jacuzzi drain is 67°F . The previous reading at 27°F outdoor temperature was also 67°F .

The subfloor is within the thermal envelope.
