Bonus Room Floor Temp Evaluation

RE: Bleeder Ducts

12/11/02

House #1

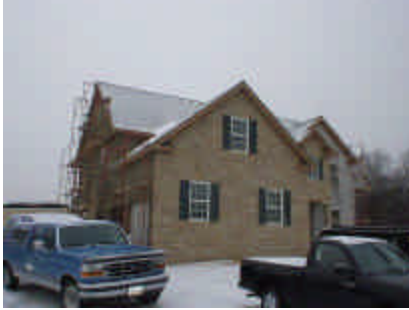
House still under construction with garage open to weather.

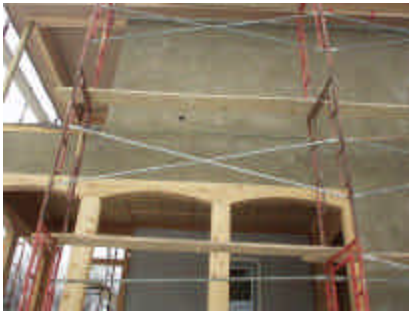
Exterior of large 2nd floor living room cantilever is open to ambient temperatures.

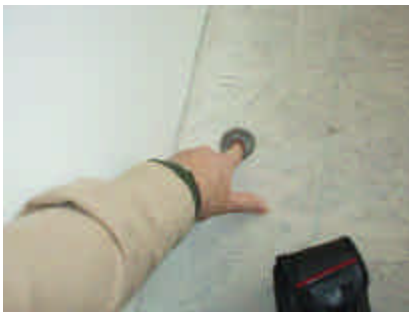
Dense floor insulation maintains even floor temperature. Cellulose insulation has filled the cavity and is against the floor.

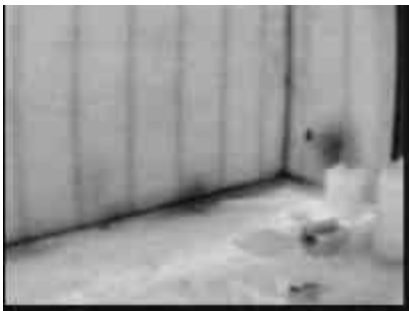
The consistent floor and wall temperatures indicate an effective thermal boundary has been established. The record of note is the toilet drain temperature of 61*. This indicates the drain in the floor cavity is within the thermal envelope; protected from freezing without the added bleeder duct.

This is a thermal image of a near perfect insulation - thermal barrier. Cellulose wall cavities are uniformly white (warm) with studs showing consistent lower R-value than cavity. Edge leaks are an imperfectly sealed sill plate and corner and are comparatively minor. Floor is a consistent warm with the white indicating a heat run to a room register.

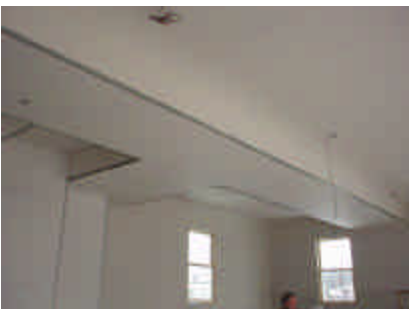
Garage ceiling is finished and was open to ambient temperature the day of the test. Box down included beam and bonus room duct runs, but no bleeder ducts.
